# Assessment of Dam Safety

## Coal Combustion Surface Impoundments (Task 3)

Pleasants Power Station

McElroys Run Dam

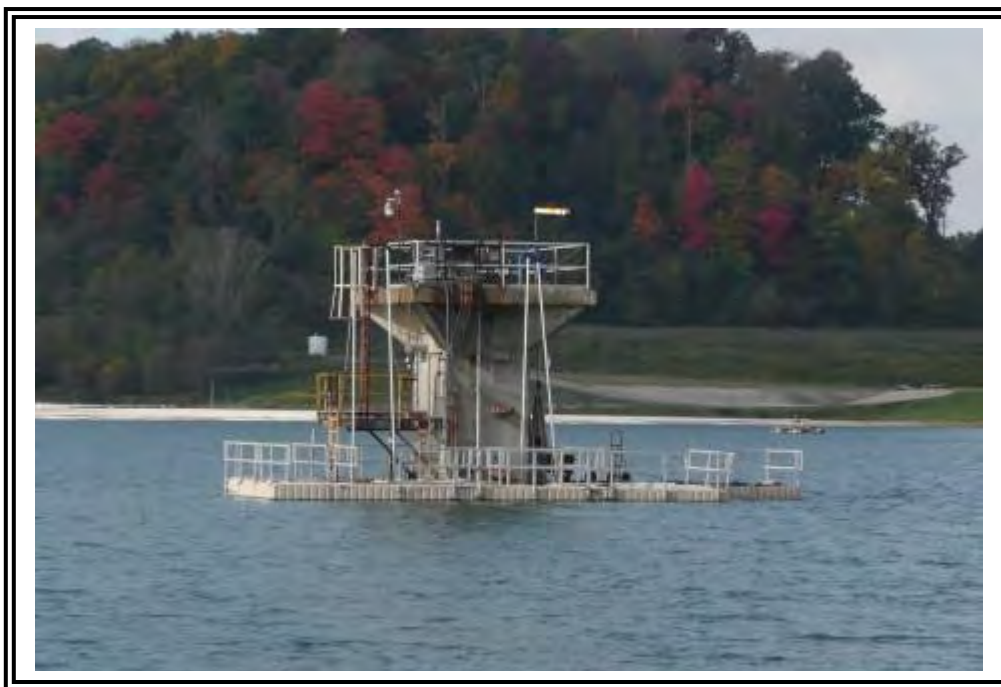
The original intake tower in McElroy's Run Dam is an isolated concrete structure accessible only by boat. The intake structure is functional through the use of sluice gates, but is not routinely used. At the time of the inspection the pond water level was well below the intake elevation. Photos 1 through 3 show this spillway tower. The tower discharges to a fabriformed basin as shown in Photos 59 and 60.

Looking west at concrete spillway tower structure and floating skimmer.

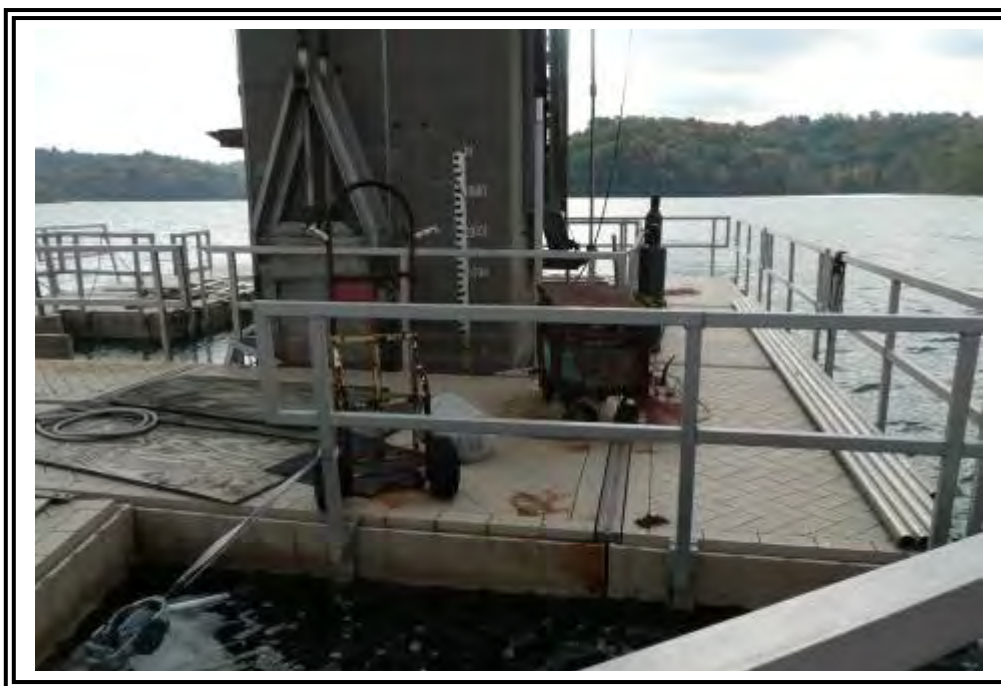
2

Closer look at spillway tower and closed sluice gates.

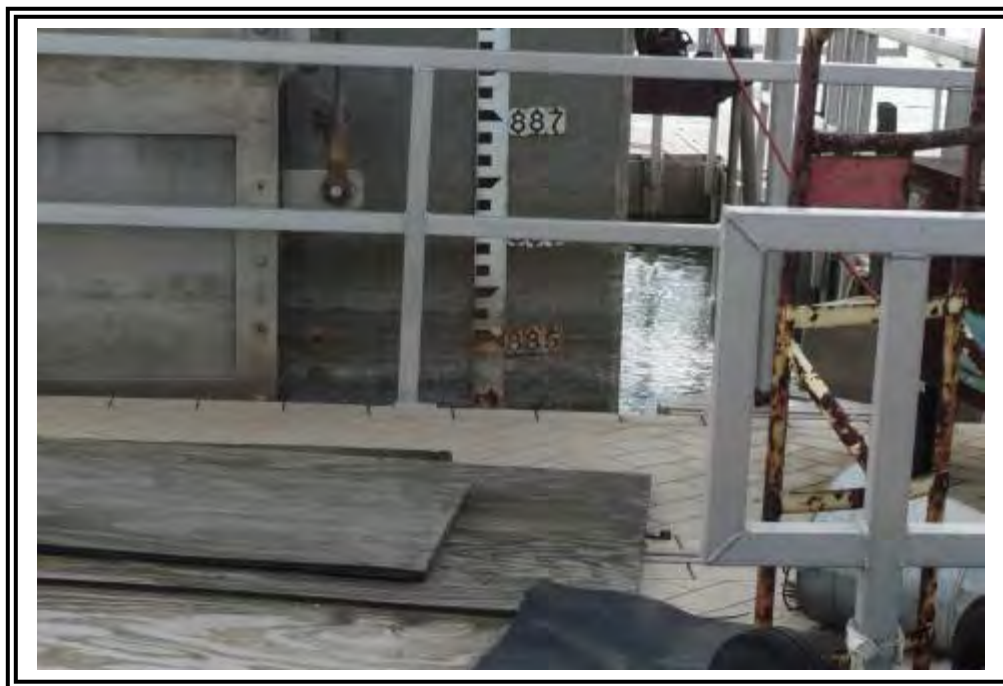
3

A close-up of the gage staff showing lake elevation level below elevation 885.

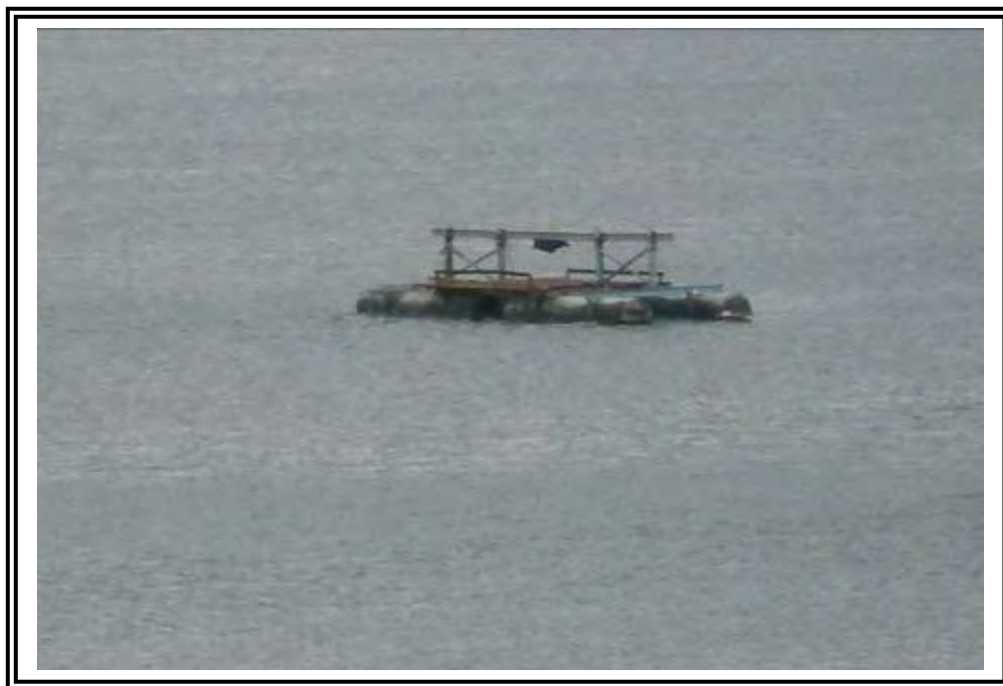
Currently water from the McElroy's Run ash disposal pond is outlet at a siphon float located near the northwest corner of the pond. This 12-inch diameter siphon can convey water either back to the Pleasants Power Station for reuse, or discharge to the Ohio River. Photo 5 shows the siphon float within the impoundment.

Siphon float (currently primary pond discharge).

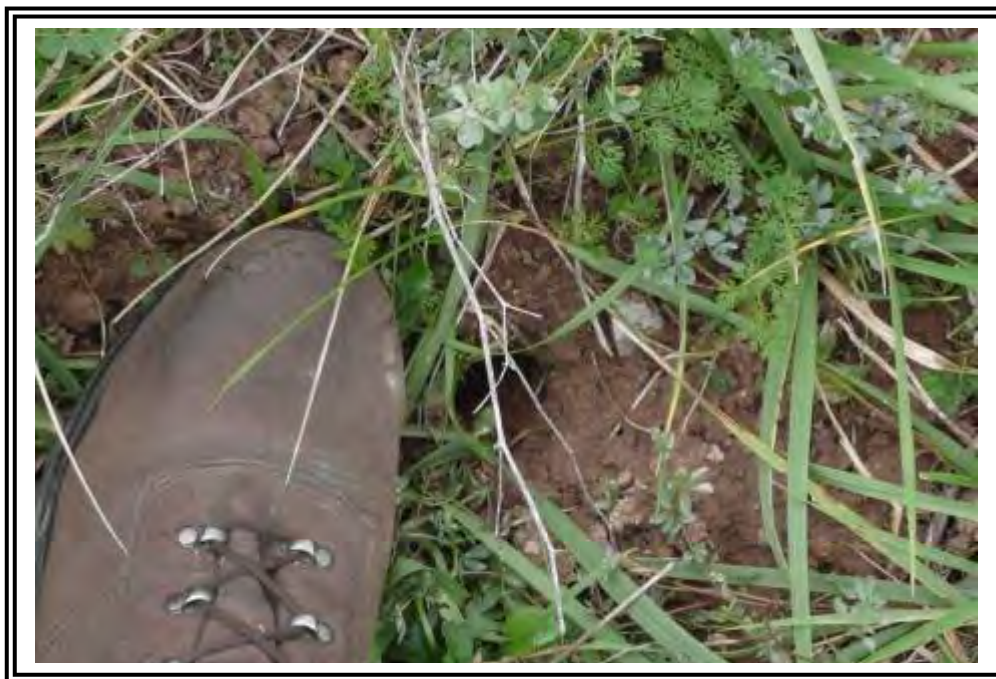
The upstream slope is grass covered with exposed soil near the water line where the water level has been lowered (Photos 4, 11, and 13) to evaluate the extent and magnitude of beach erosion at the water line. Photos 11 and 12 show the level of beach erosion. There were a few areas where the vegetation cover was thin and surface erosion was occurring, and a couple isolated small animal burrows. These types of features are shown in Photos 8 through 10.

Small isolated animal (possibly reptile) burrow in upstream slope face.

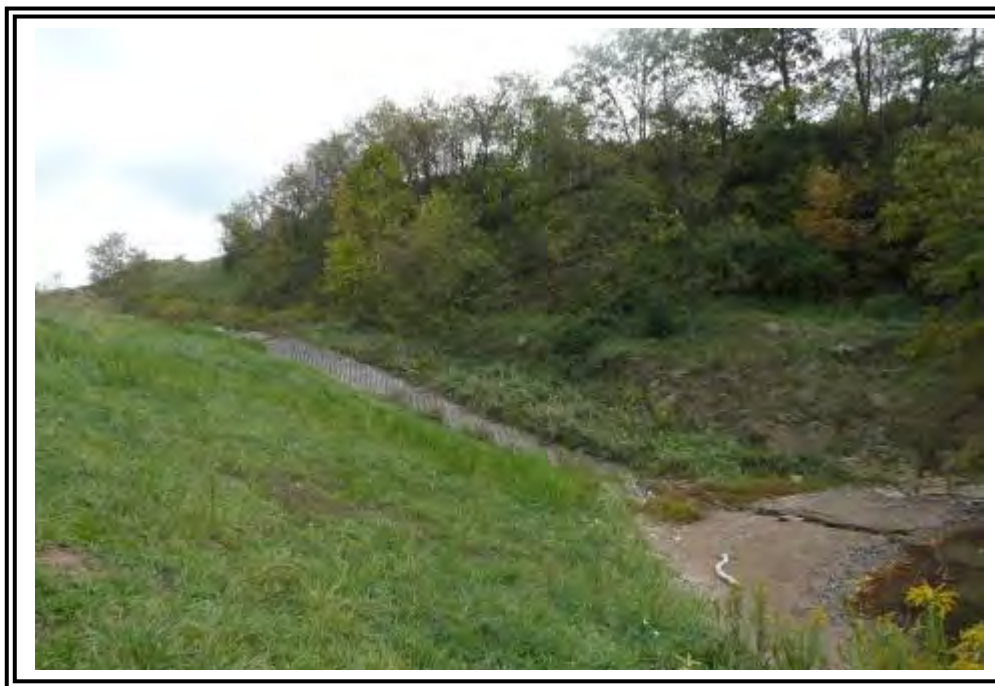
14

Upstream slope at right (east) abutment contact, looking east. Break in tree line above slope is location of upstream core trench at the right abutment contact. Note Fabriform lined groin at abutment contact.

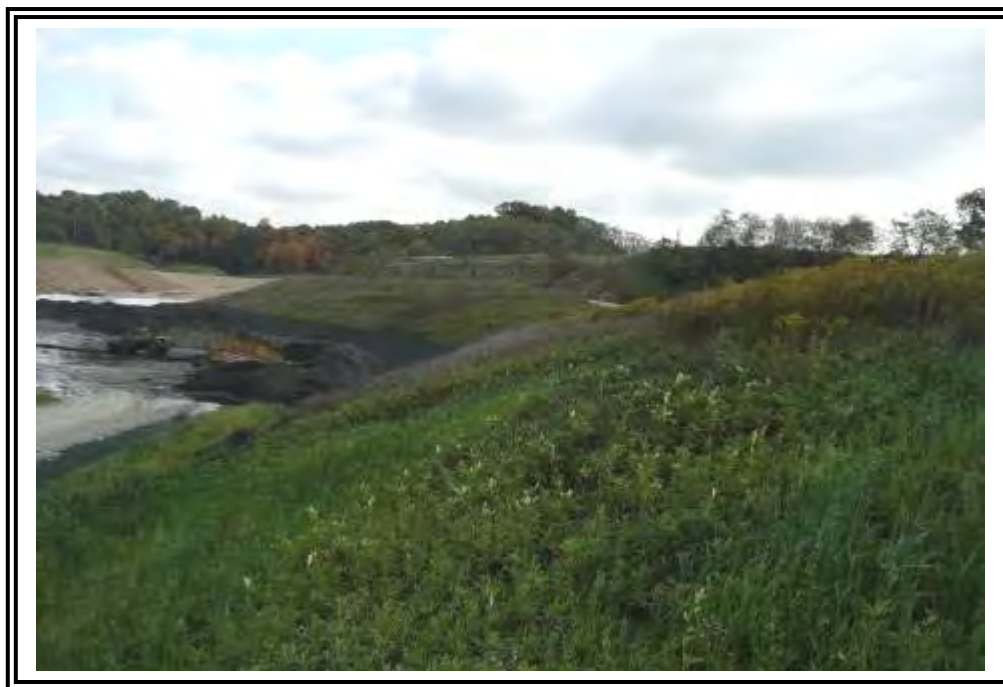
The downstream slope is grass covered with an active landfill buttress being built up against it. Photos 21 and 22 show the upper portion of the downstream slope and the placement of a bottom ash blanket drain at the active landfill construction area. Similar to conditions on the upstream slope, Photos 23 through 25 show typical conditions with thin vegetation cover and erosion rills obscured by thicker vegetation on the downstream slope above the landfill.

Looking east along downstream slope face and bottom ash being stockpiled for drainage blanket at slope toe.

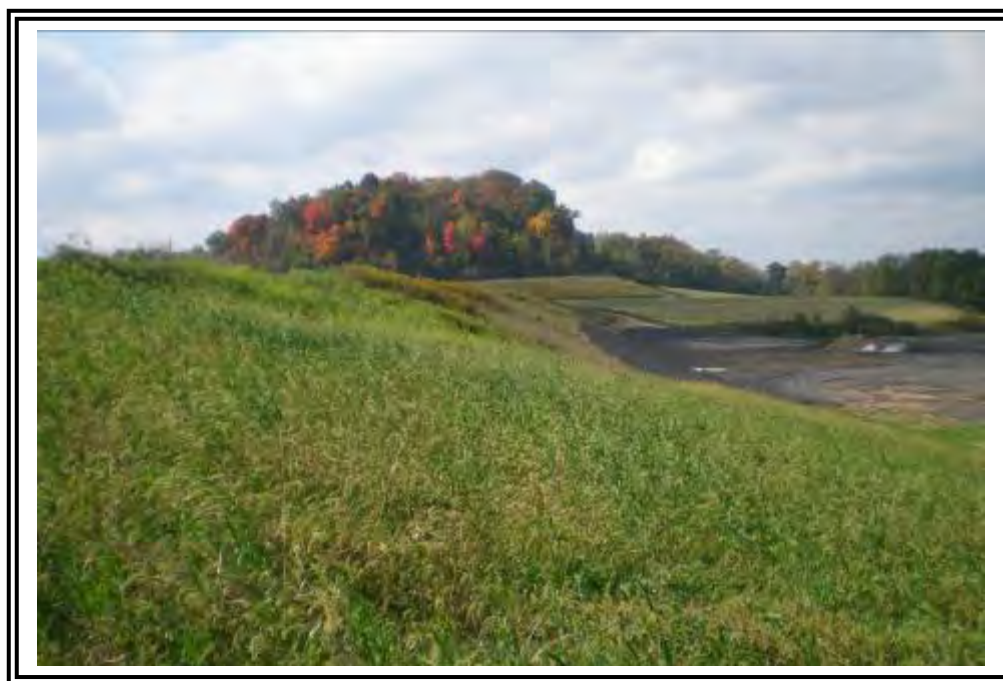
22

Looking west along downstream slope face. Note bottom ash drainage blanket on slope in landfill buttress area.

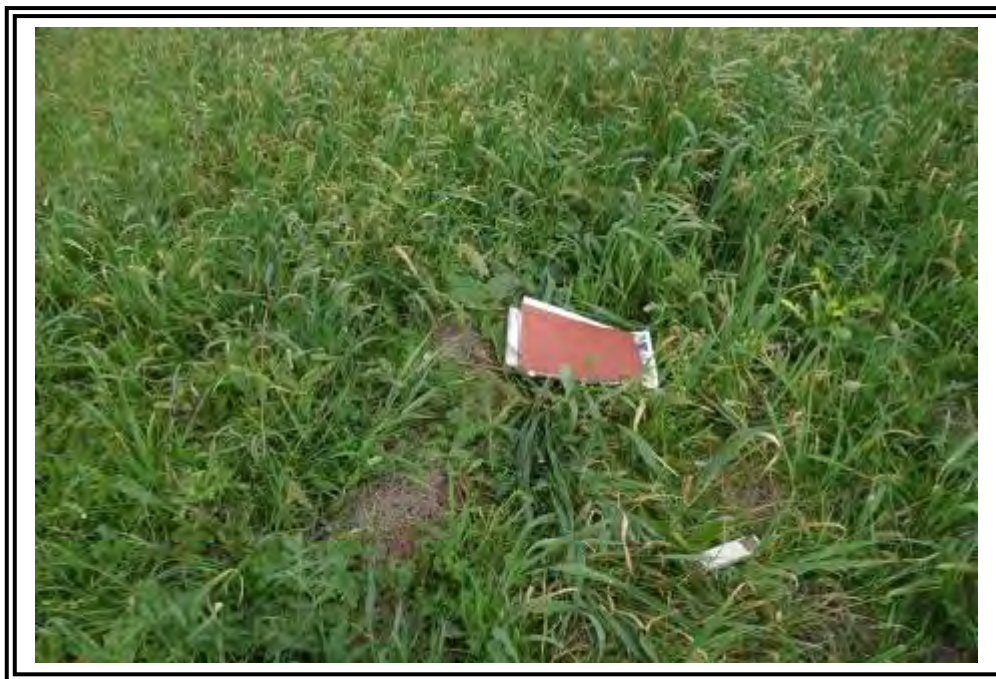
24

Vegetated, obscured erosion rill on downstream slope (beneath clipboard).

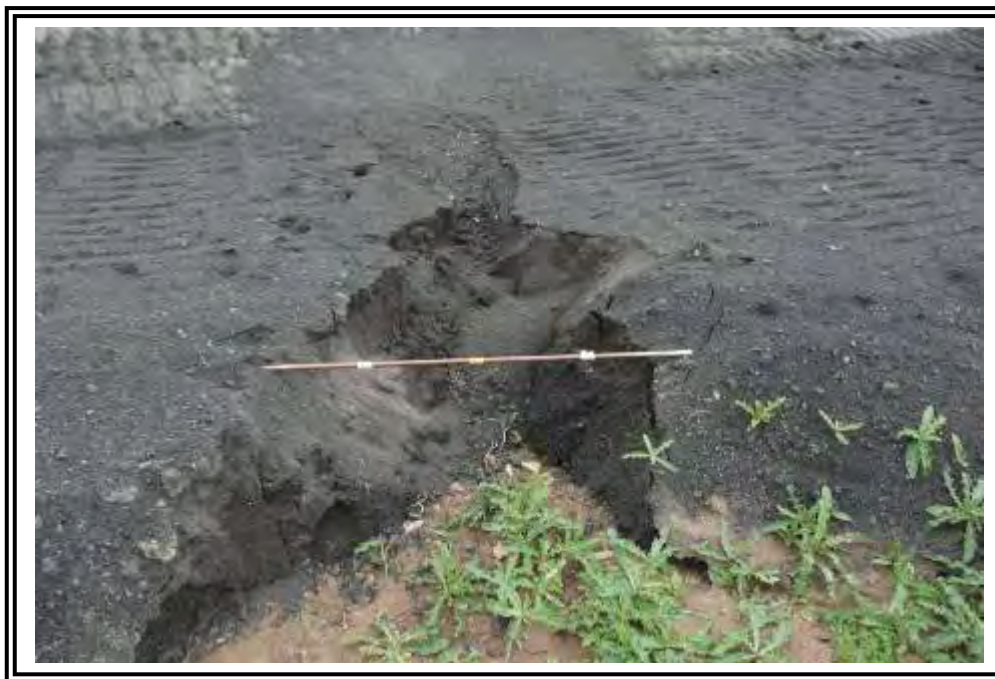
26

Landfill benches below the bench currently under construction are grass covered with occasional isolated woody vegetation. Occasional loss of grass cover and rutting from mowing equipment, and occasional active and repaired rodent burrows were observed. There were some deep (6 to 10 inches) erosion rills in the area where recent re-grading for the recently constructed access road has occurred on the east side and in the recently placed bottom ash blanket drain as shown in Photos 37 and 26, respectively.

Erosion gully at top of the bottom ash drainage blanket being placed on the active buttress landfill bench.

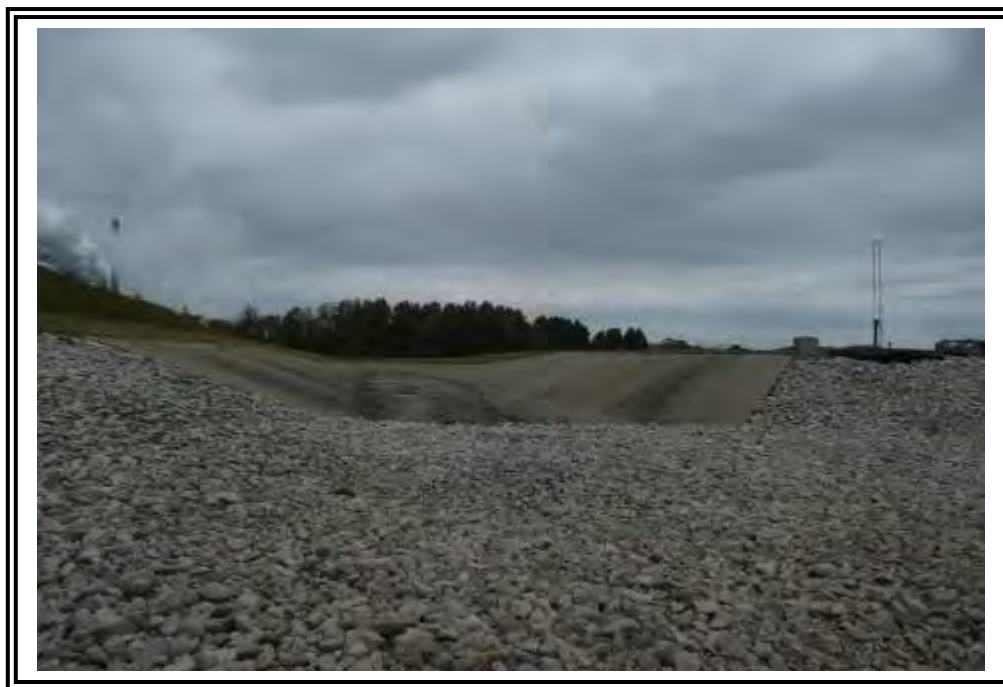
To the west of the dam there is a concrete emergency spillway as shown in Photos 31 through 35. The approach to the concrete paving is lined with stone rip rap (Photo 31), and there is grouted riprap protection at the outlet of the emergency spillway as shown in Photo 35. Loose caulk was noted at some of the joints between concrete paving panels as shown in Photo 33.

Looking northwest (downstream) from upstream slope at emergency spillway.  
Note stone slope protection at entrance.

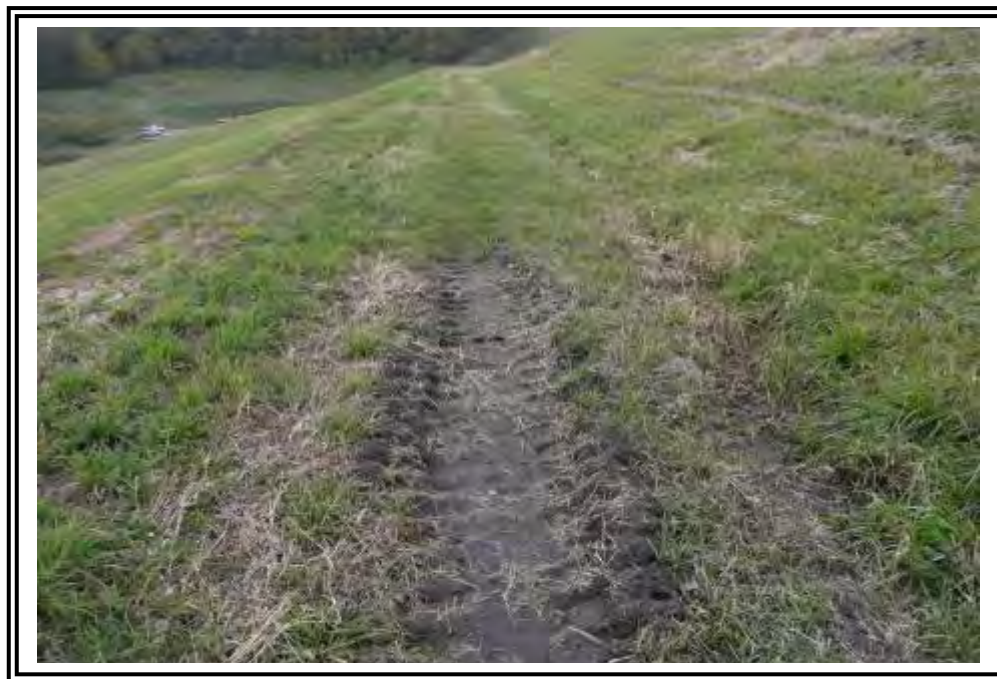
42

Rutting from mowing equipment on bench in water deposited ash along buttress landfill slope.

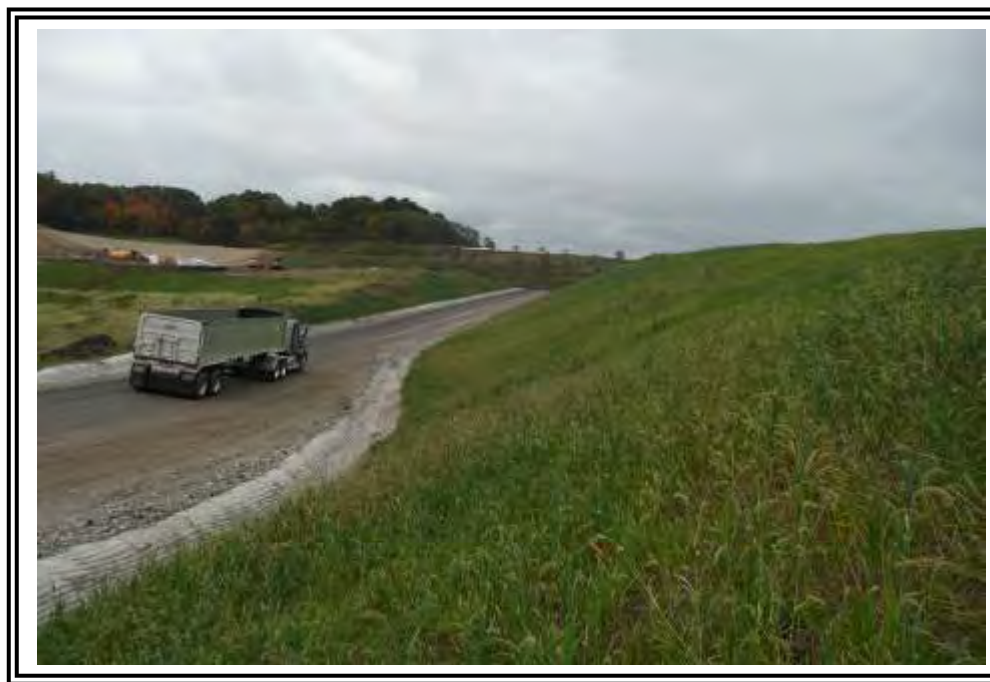
46

Looking southeast along the landfill buttress slope adjacent to active haul road. Slope is steeper adjacent to road.

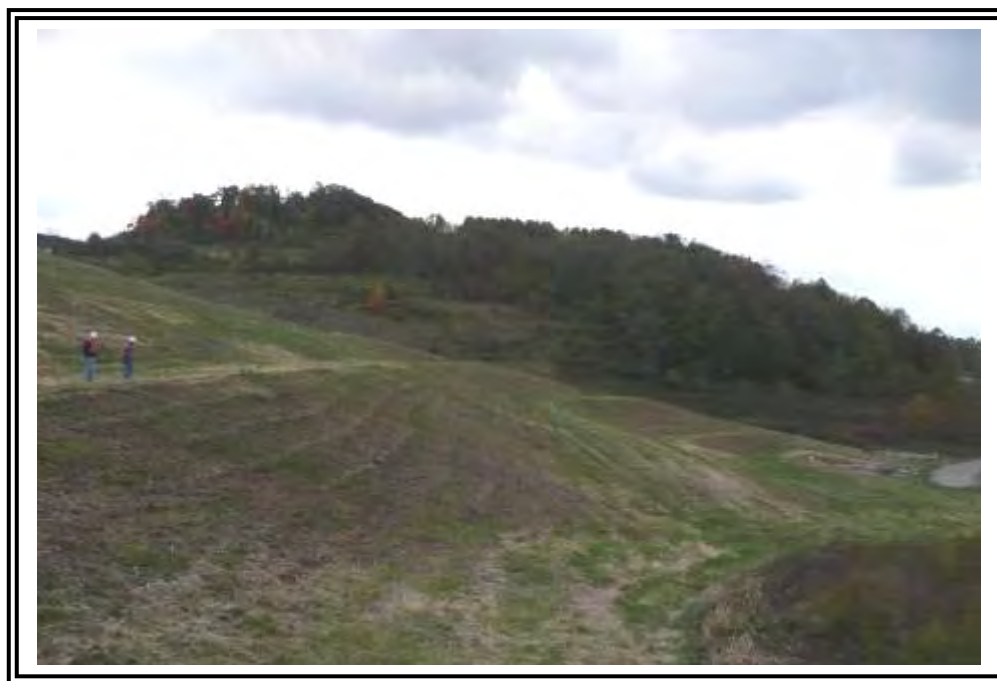
50

Looking west across buttress landfill slope showing older construction benches. Grass and soil cover appears more stable and less susceptible to erosion on these lower benches.

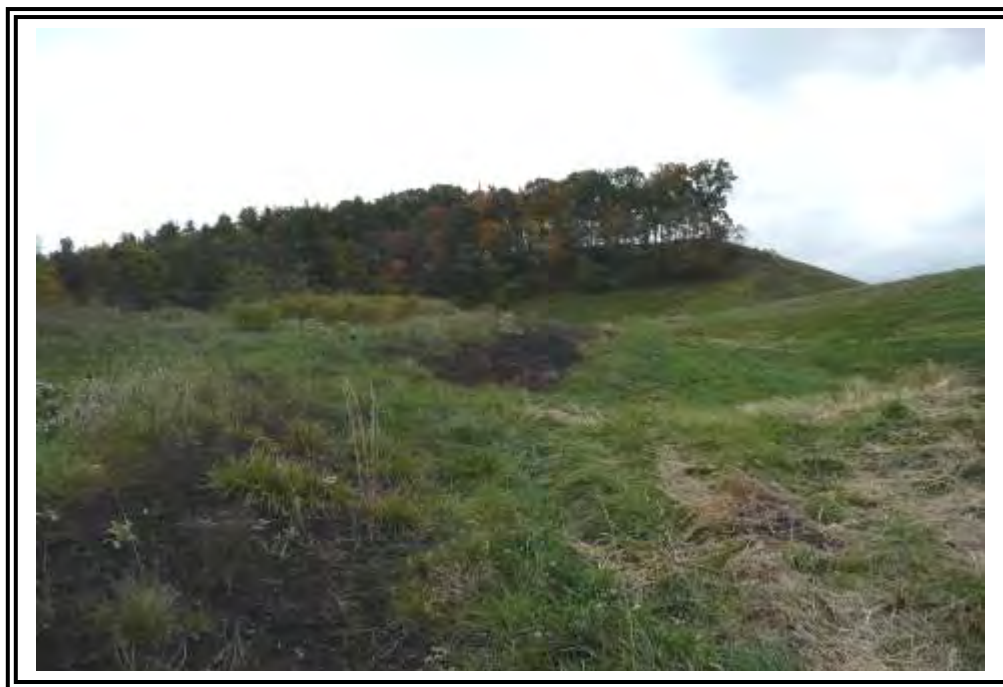
51

Close up of bottom ash groin and blanket drain on right abutment contact. Note sporadic grass on groin.

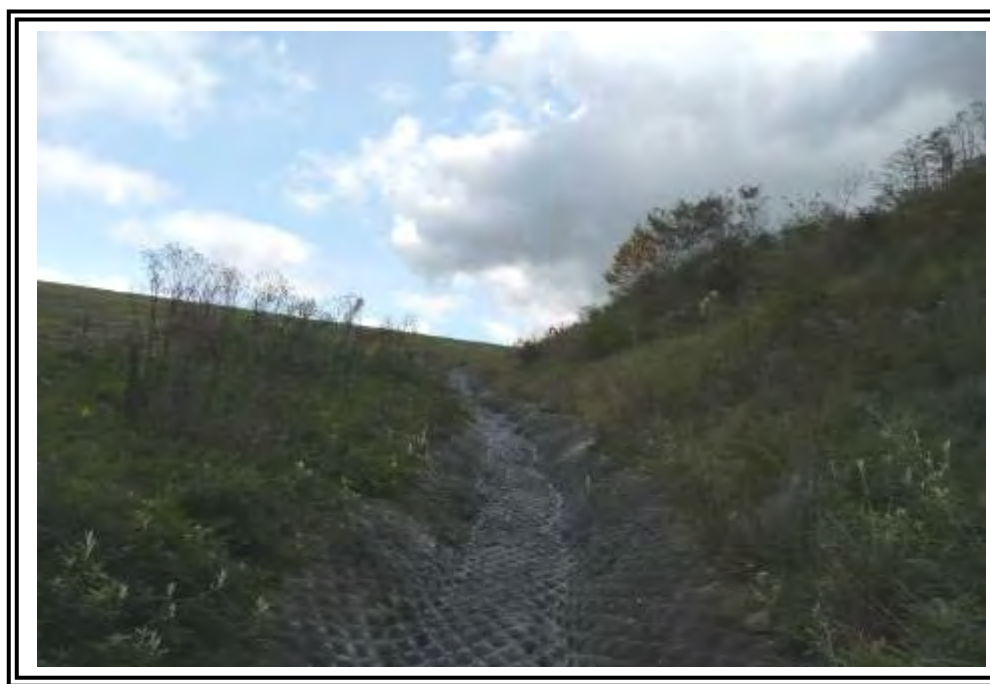
56

Looking up-slope at fabric formed concrete groin on west (left) buttress landfill abutment.

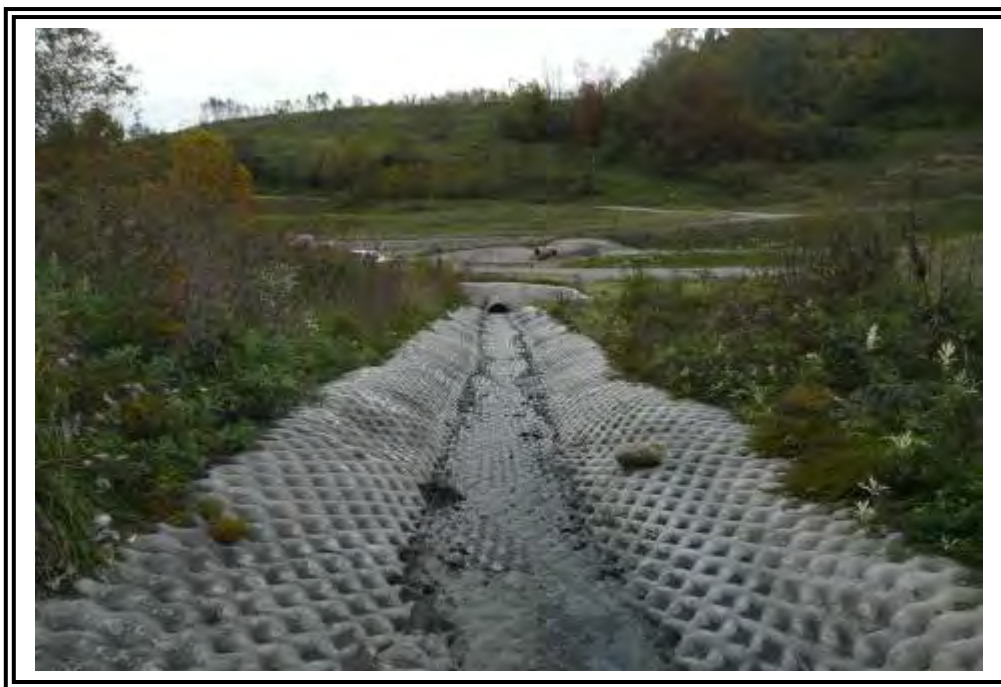
58

Looking down-slope at fabric formed concrete groin on west (left) buttress landfill abutment.

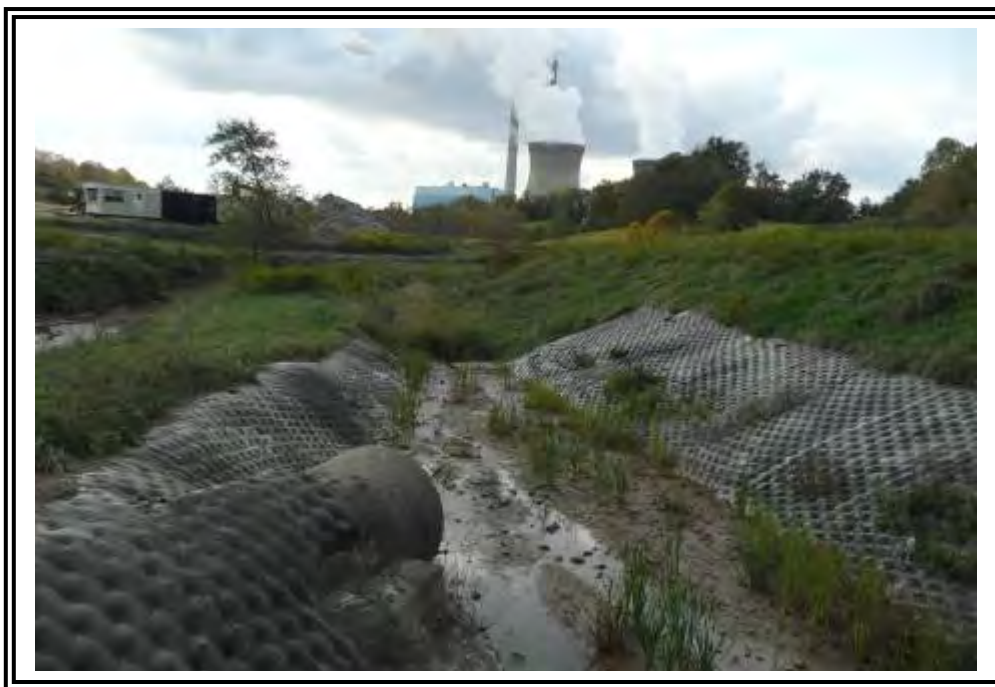
59

Looking downstream at spillway outlet basin.

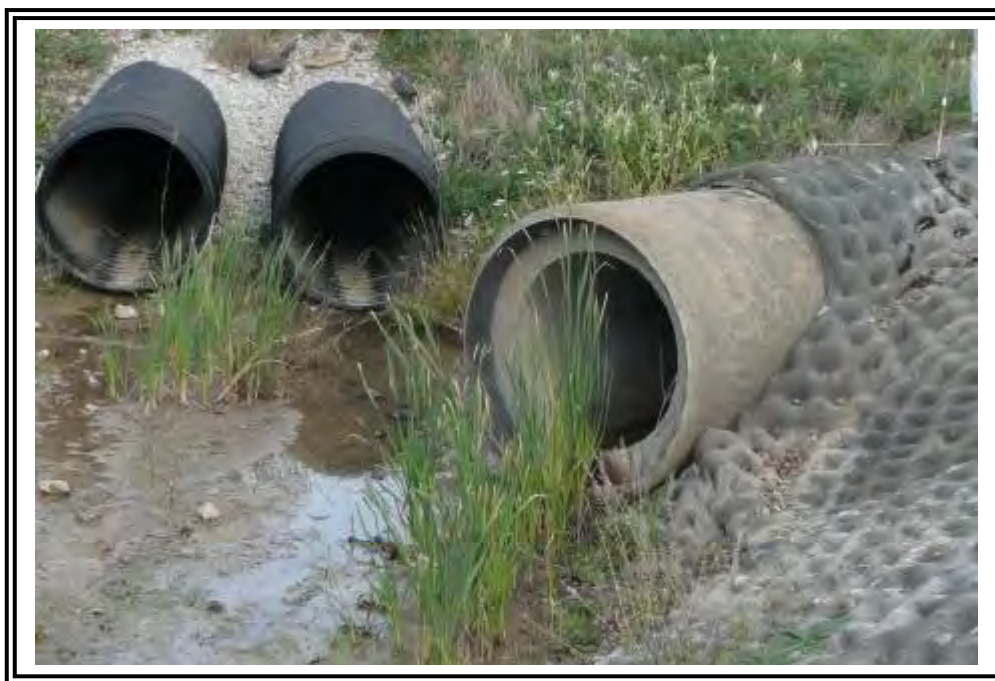
60

Concrete spillway outlet. Water does not normally flow through outlet.  
Water leaves outlet via a siphon with an outfall in the Ohio River.

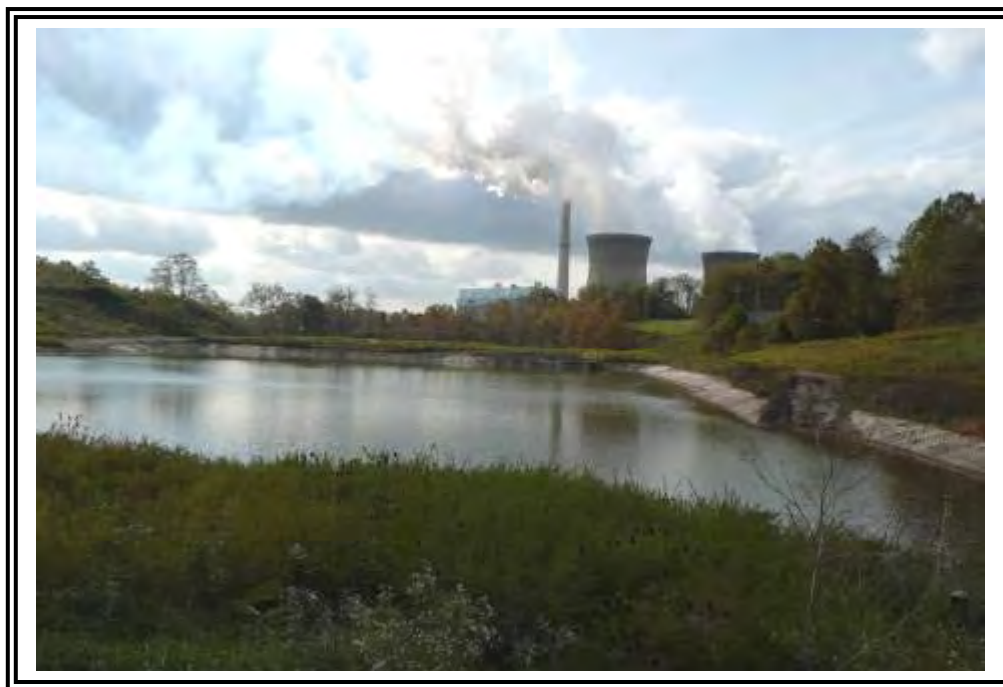
61

Sedimentation Basin No.1 for landfill and storm water runoff. Predominantly incised.

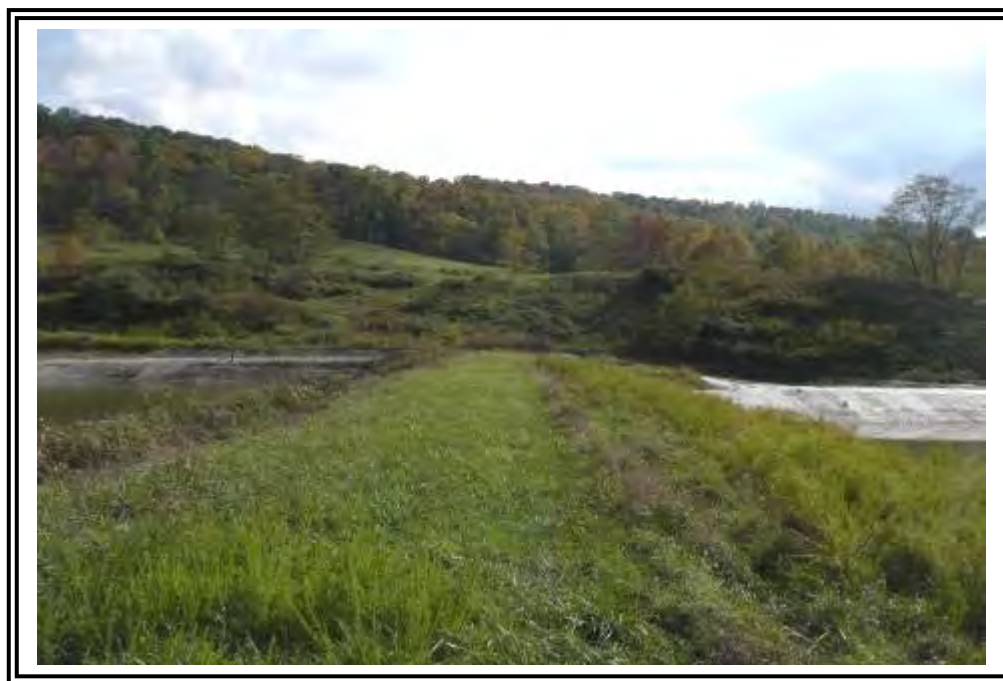
62

Separation dike between Sedimentation Basin No.1 and Sedimentation Basin No.2

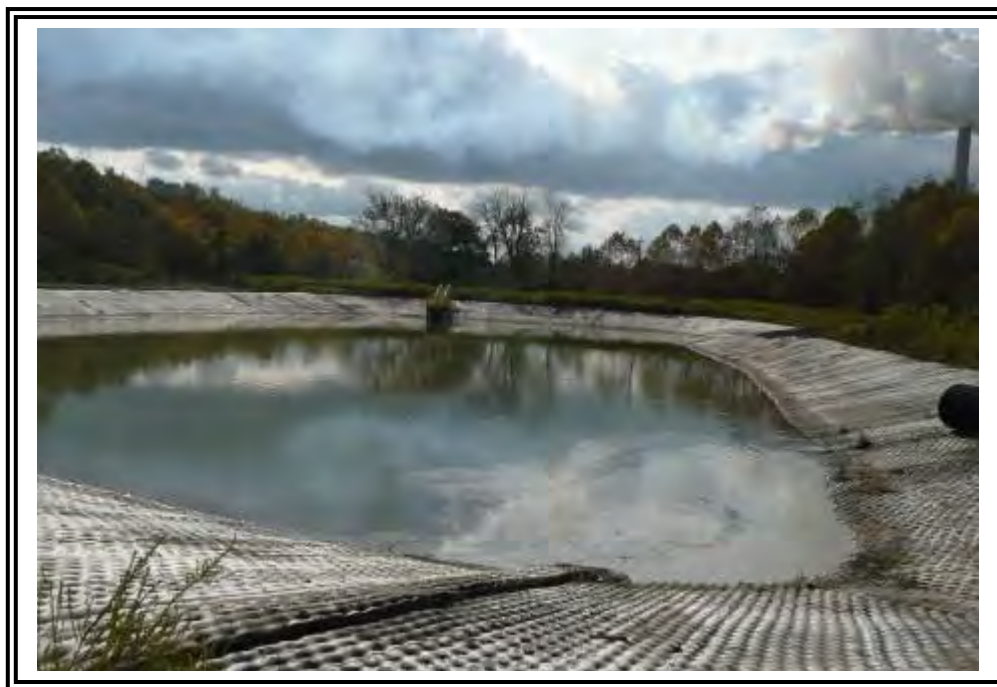
63

Sedimentation Basin No.2 for general site runoff and outfall from Sedimentation Basin No.1.

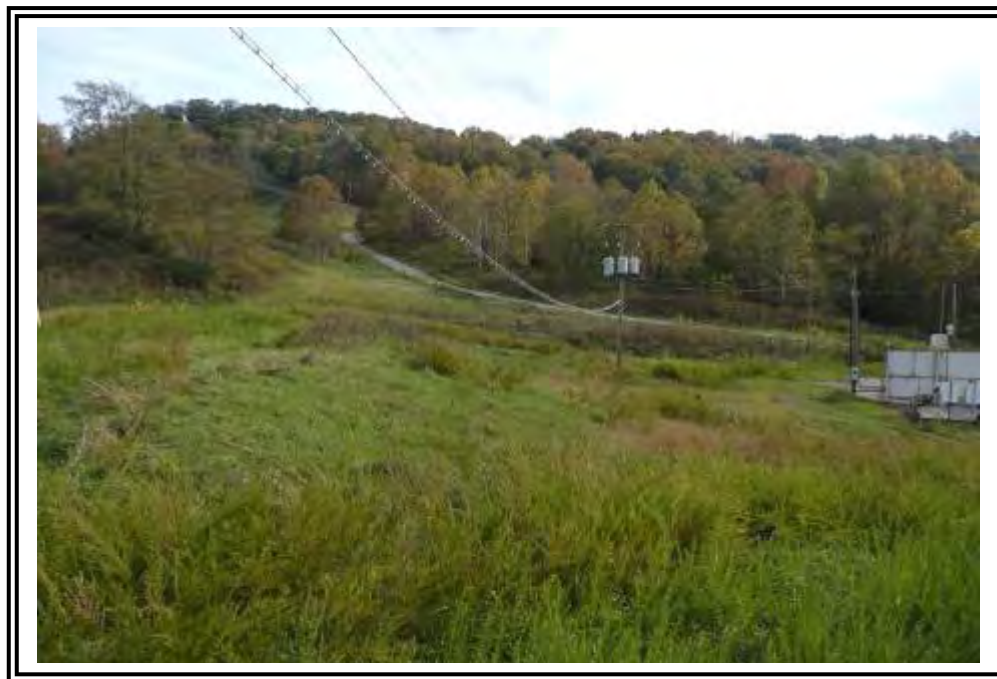
64

Downstream slope of Sedimentation Basin No. 2 showing pump house structure (right side of photo). Pump house conveys effluent from Sedimentation Basin No.2 back up to the McElroy's Run Impoundment.

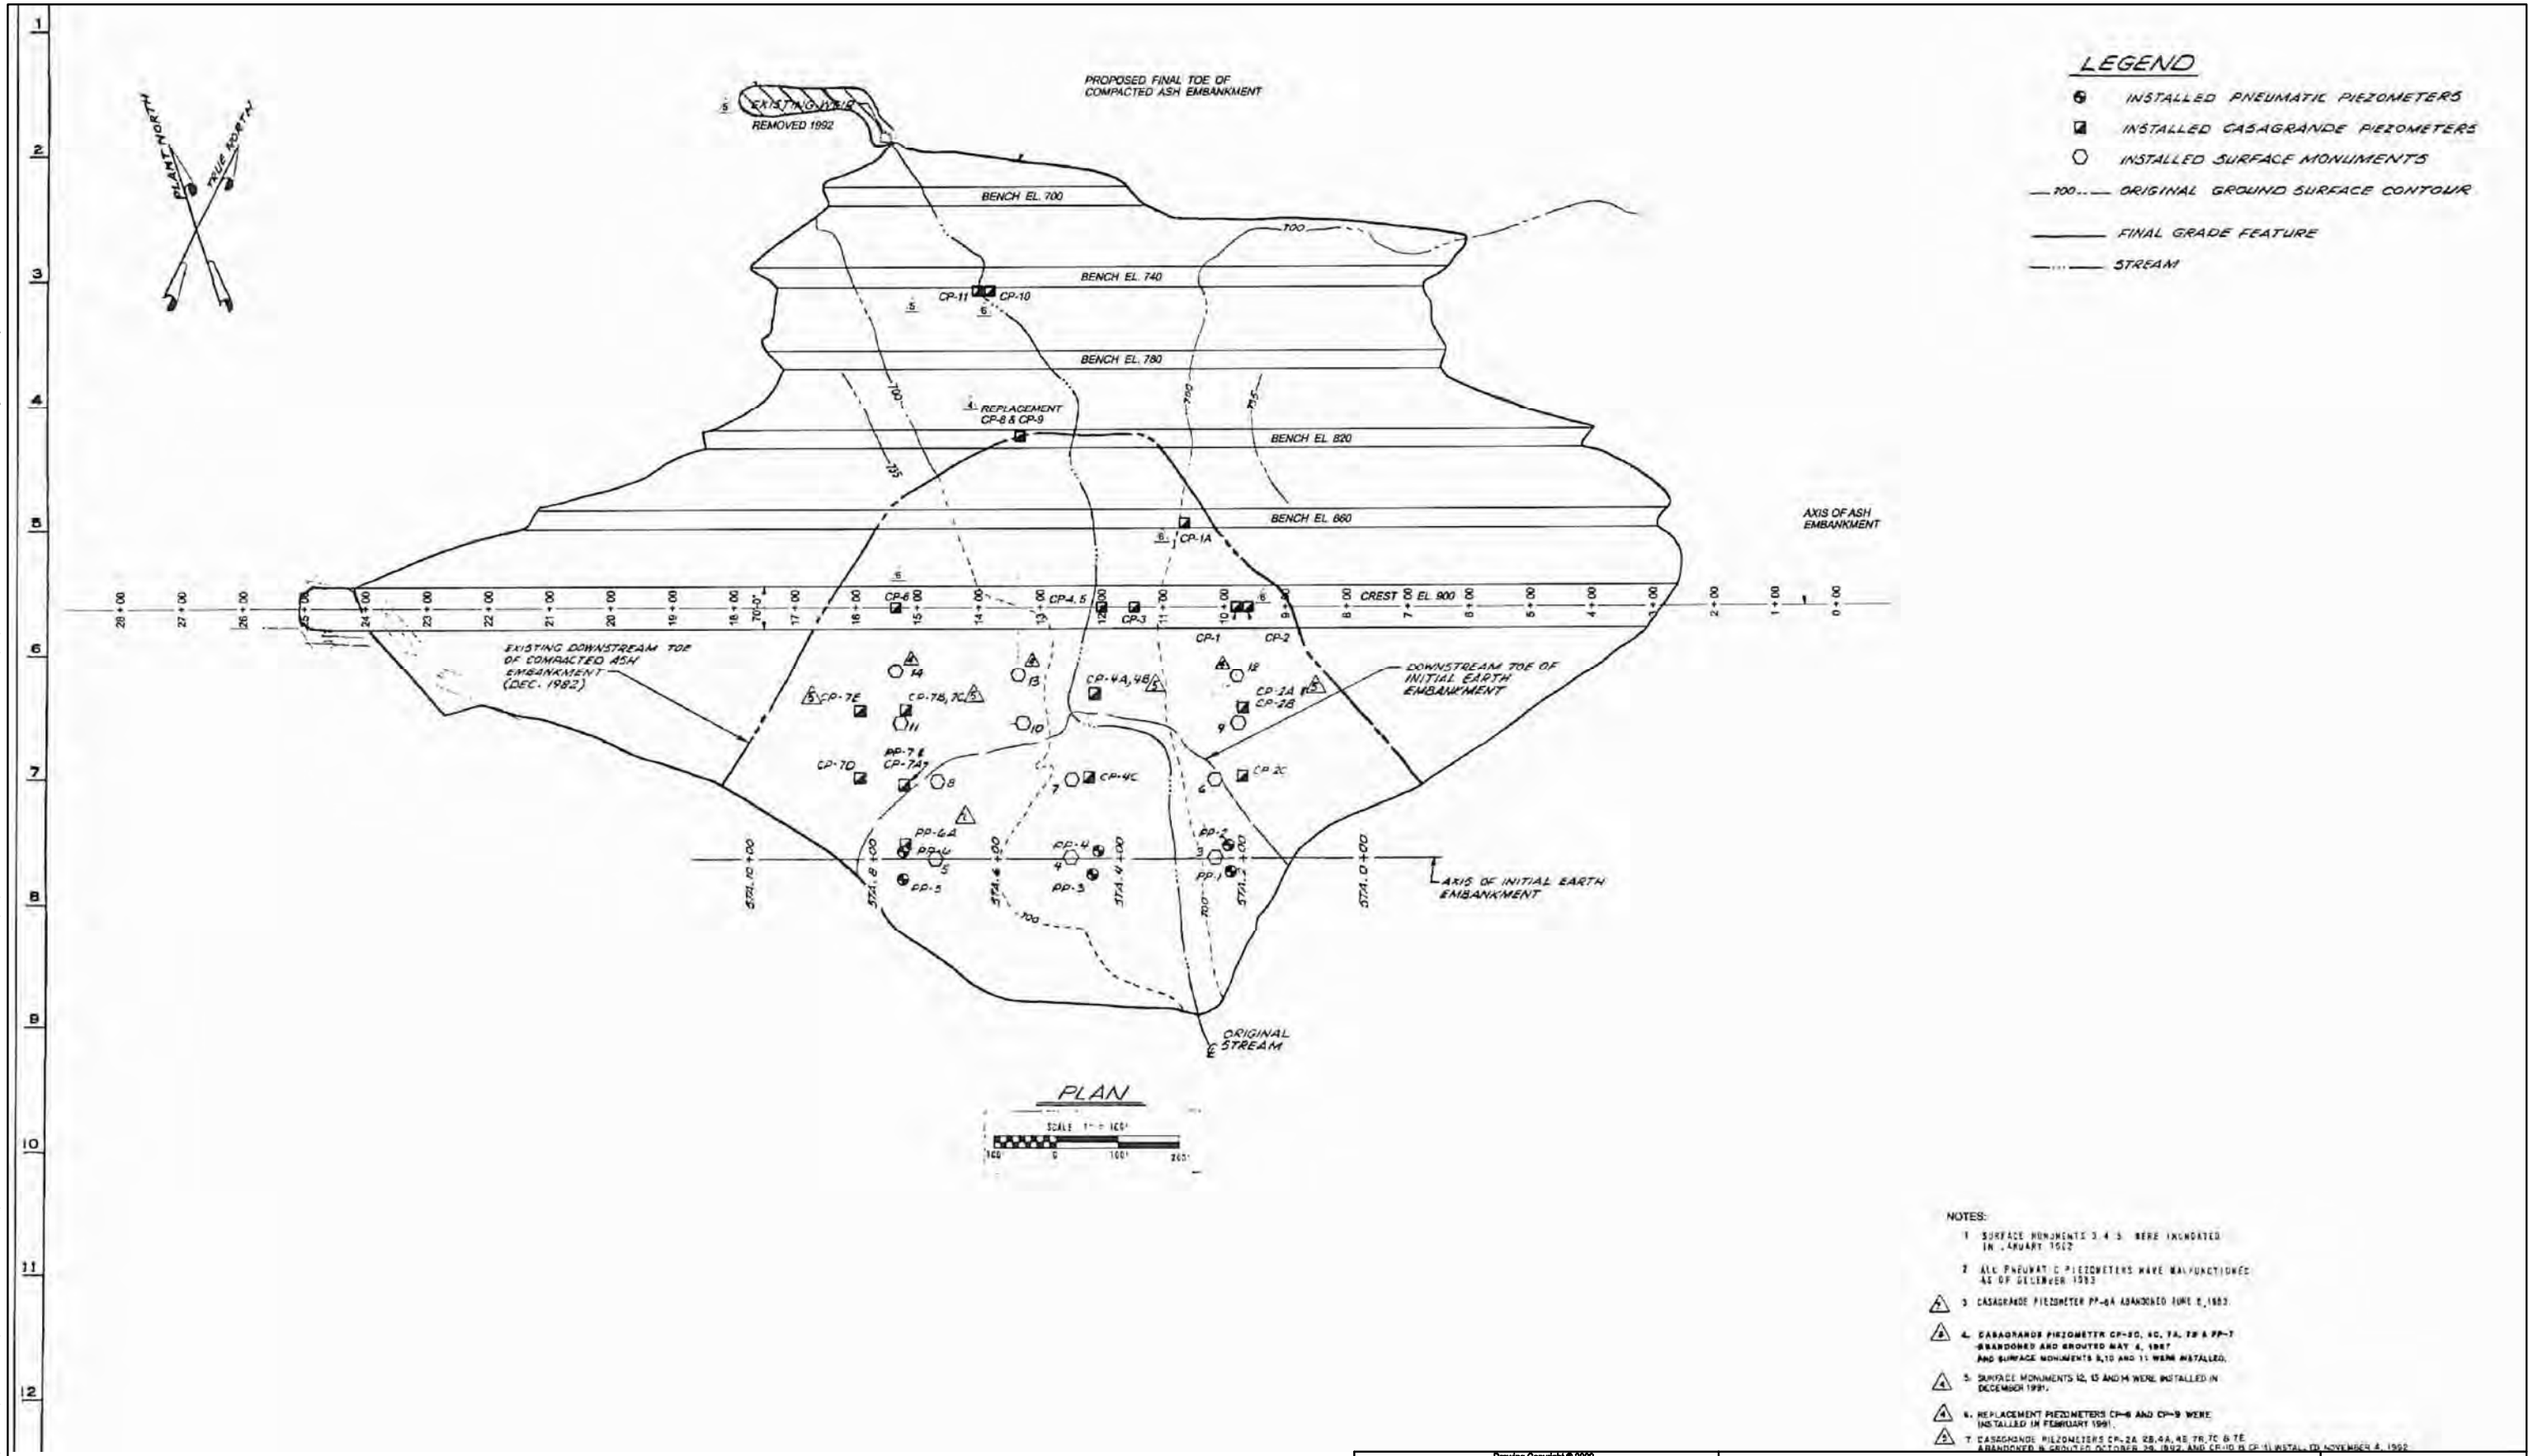
<div><p>Drawing Copyright © 2009</p><p>III Winners Circle, PO Box 5289 · Albany, NY 12205-0289 Main: (518) 463-4500 · www.chacompanies.com</p></div>	INSTRUMENT LOCATION PLAN		PROJECT NO. 20085.6000
	PLEASANTS POWER STATION PLEASANTS COUNTY, WEST VIRGINIA		DATE: NOV 2009
			FIGURE 8

There is monitoring instrumentation installed at McElroy's Run Dam. Figure 8 shows the approximate locations of instrumentation. The locations shown in Figure 8 represent what was provided to CHA although Allegheny Energy acknowledged that some of these locations have been closed and buried as the landfill has been built up. Therefore, this figure should not be considered an accurate depiction of currently operating instrumentation, but rather what has been installed and monitored at some point during the life of the facility.

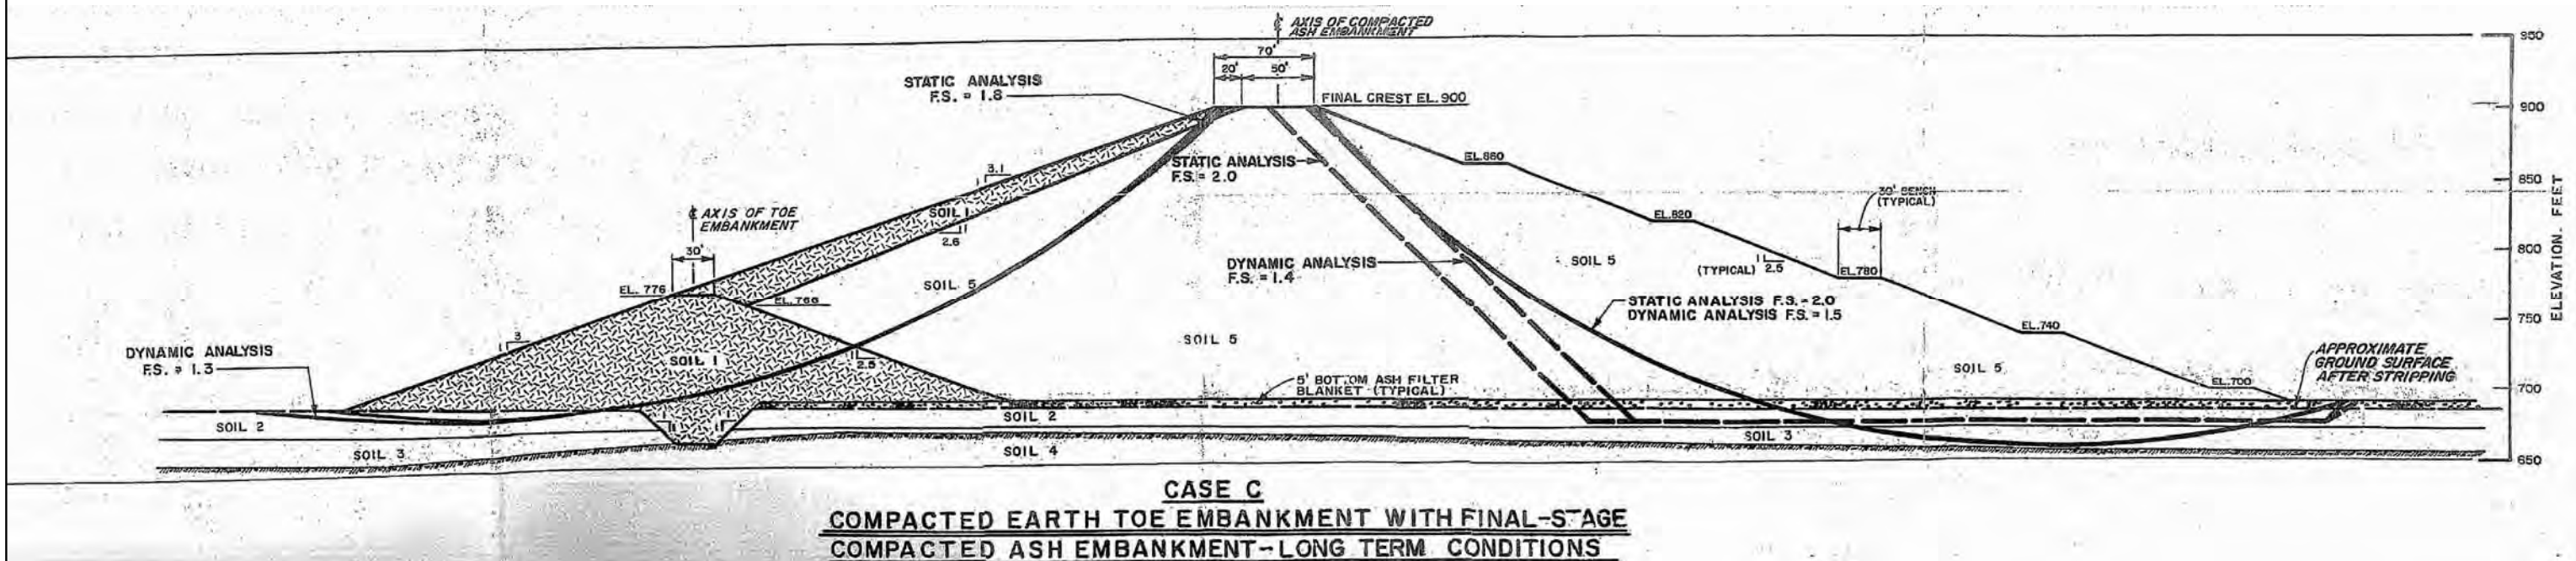
Drawing Copyright © 2008 III Winners Circle, PO Box 5269 - Albany, NY 12205-0269 Main: (518) 453-4500 • www.chacompanies.com	MCELROY'S RUN DAM MAIN EMBANKMENT STABILITY		PROJECT NO. 20085.6000
	PLEASANTS POWER STATION PLEASANTS COUNTY, WEST VIRGINIA		DATE: AUG 09
			FIGURE 9

The west abutment area at the McElroy's Run Dam reportedly has a history of geologic instability. This instability is reportedly the result of the plunge of the Burning Springs Anticline, which contributes abundant groundwater. Allegheny Energy performed stabilizing work on the left slope downstream of the dam with a grid of concrete columns in about 2001. To confirm the dam's stability, GAI performed stability analyses in this left section of the dam following subsurface explorations and laboratory testing of soils. GAI noted that slickensides were observed within the colluvial soils overlying intact bedrock, and therefore residual shear strength friction angles were used in the analyses. Figures 6A and 6B show geologic sections of the dam in this area. Original design sections for the dam show a much thinner layer of soil overlying intact bedrock in the mid section of the dam than toward the abutments (see Figure 9).
